MOUND LABORATORY
Operated By
MONSANTO CHEMICAL COMPANY
MIAMISBURG, OHIO

REPORT NO. 3 OF STEERING COMMITTEE
FOR DISPOSAL OF UNITS III AND IV

(Completion Report for Disposal of Unit IV,
Runnymede Road and Dixon Ave. Dayton, Ohio)

Date: April 17, 1950

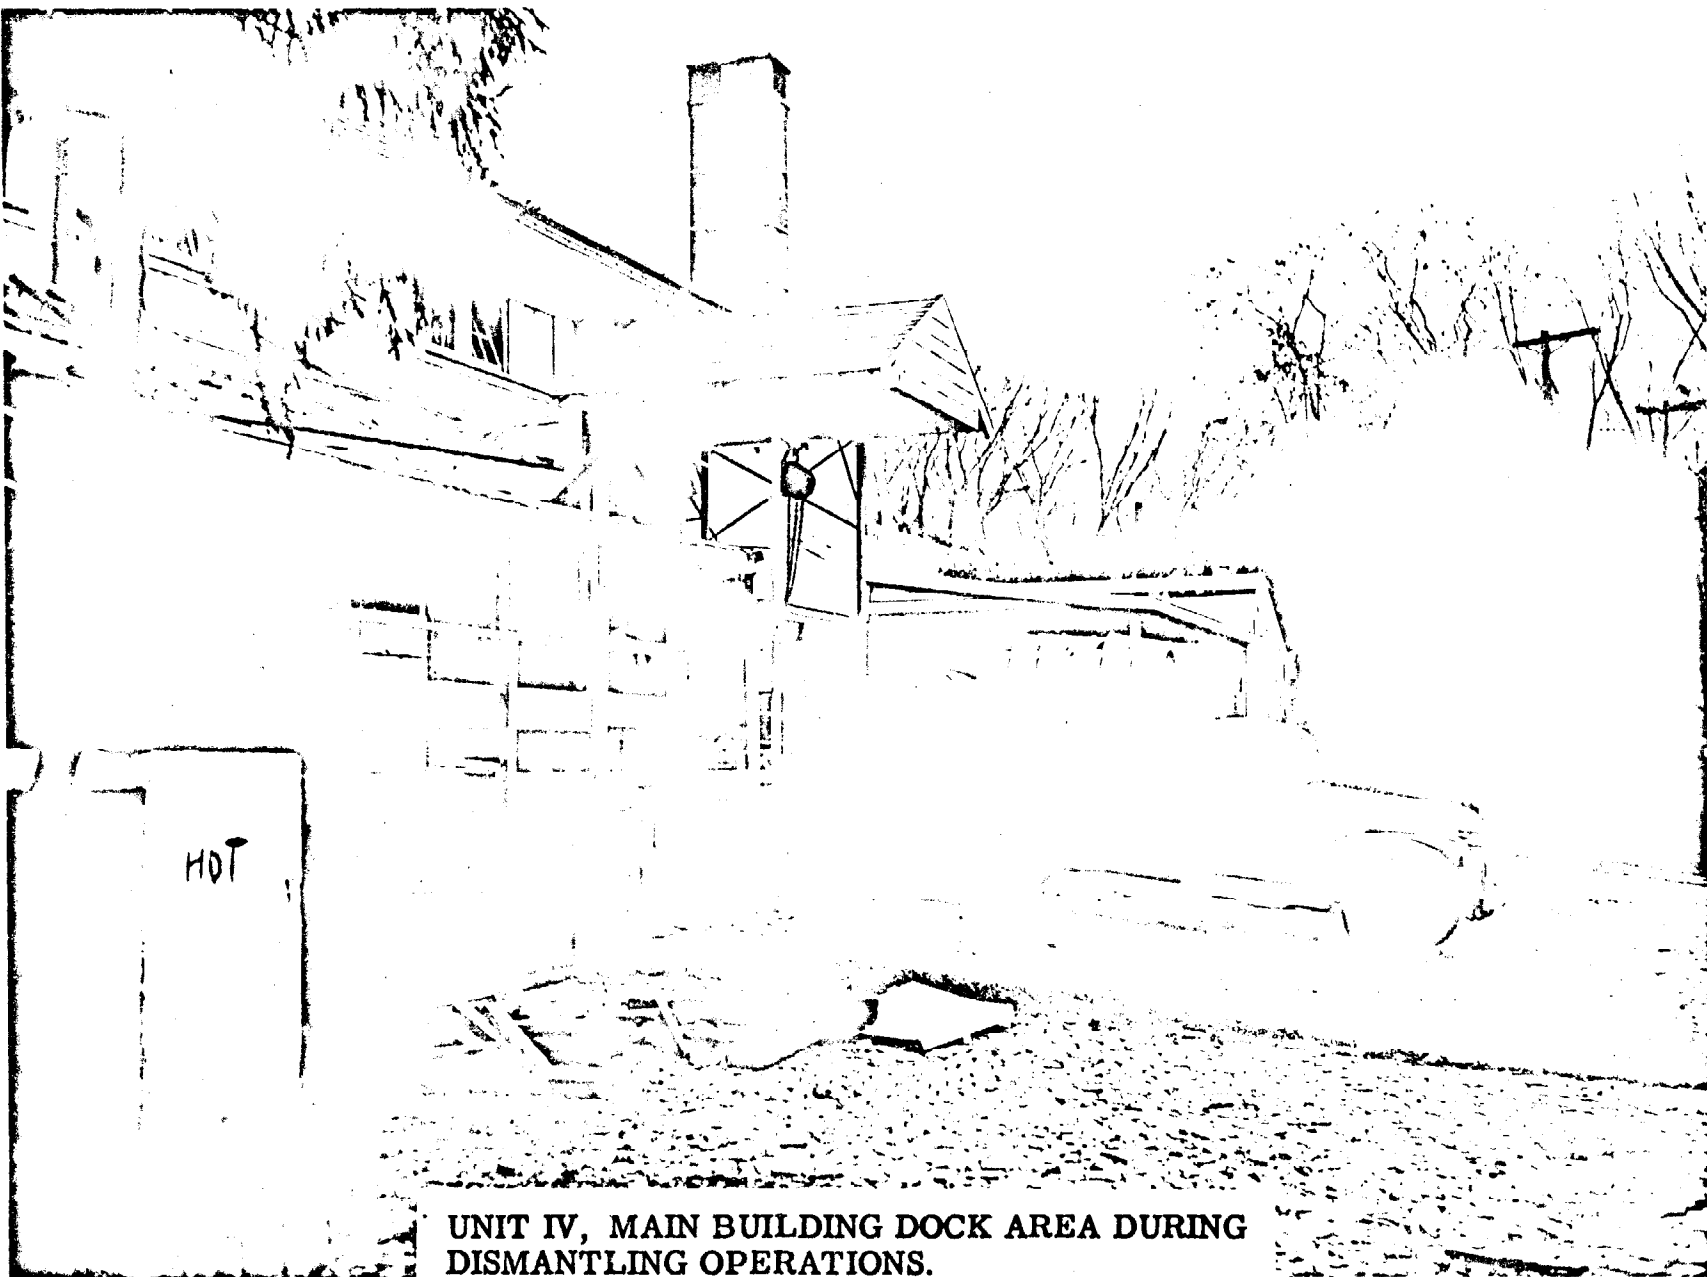
FIGURE 3

UNIT IV, MAIN BUILDING DOCK AREA DURING
DISMANTLING OPERATIONS.

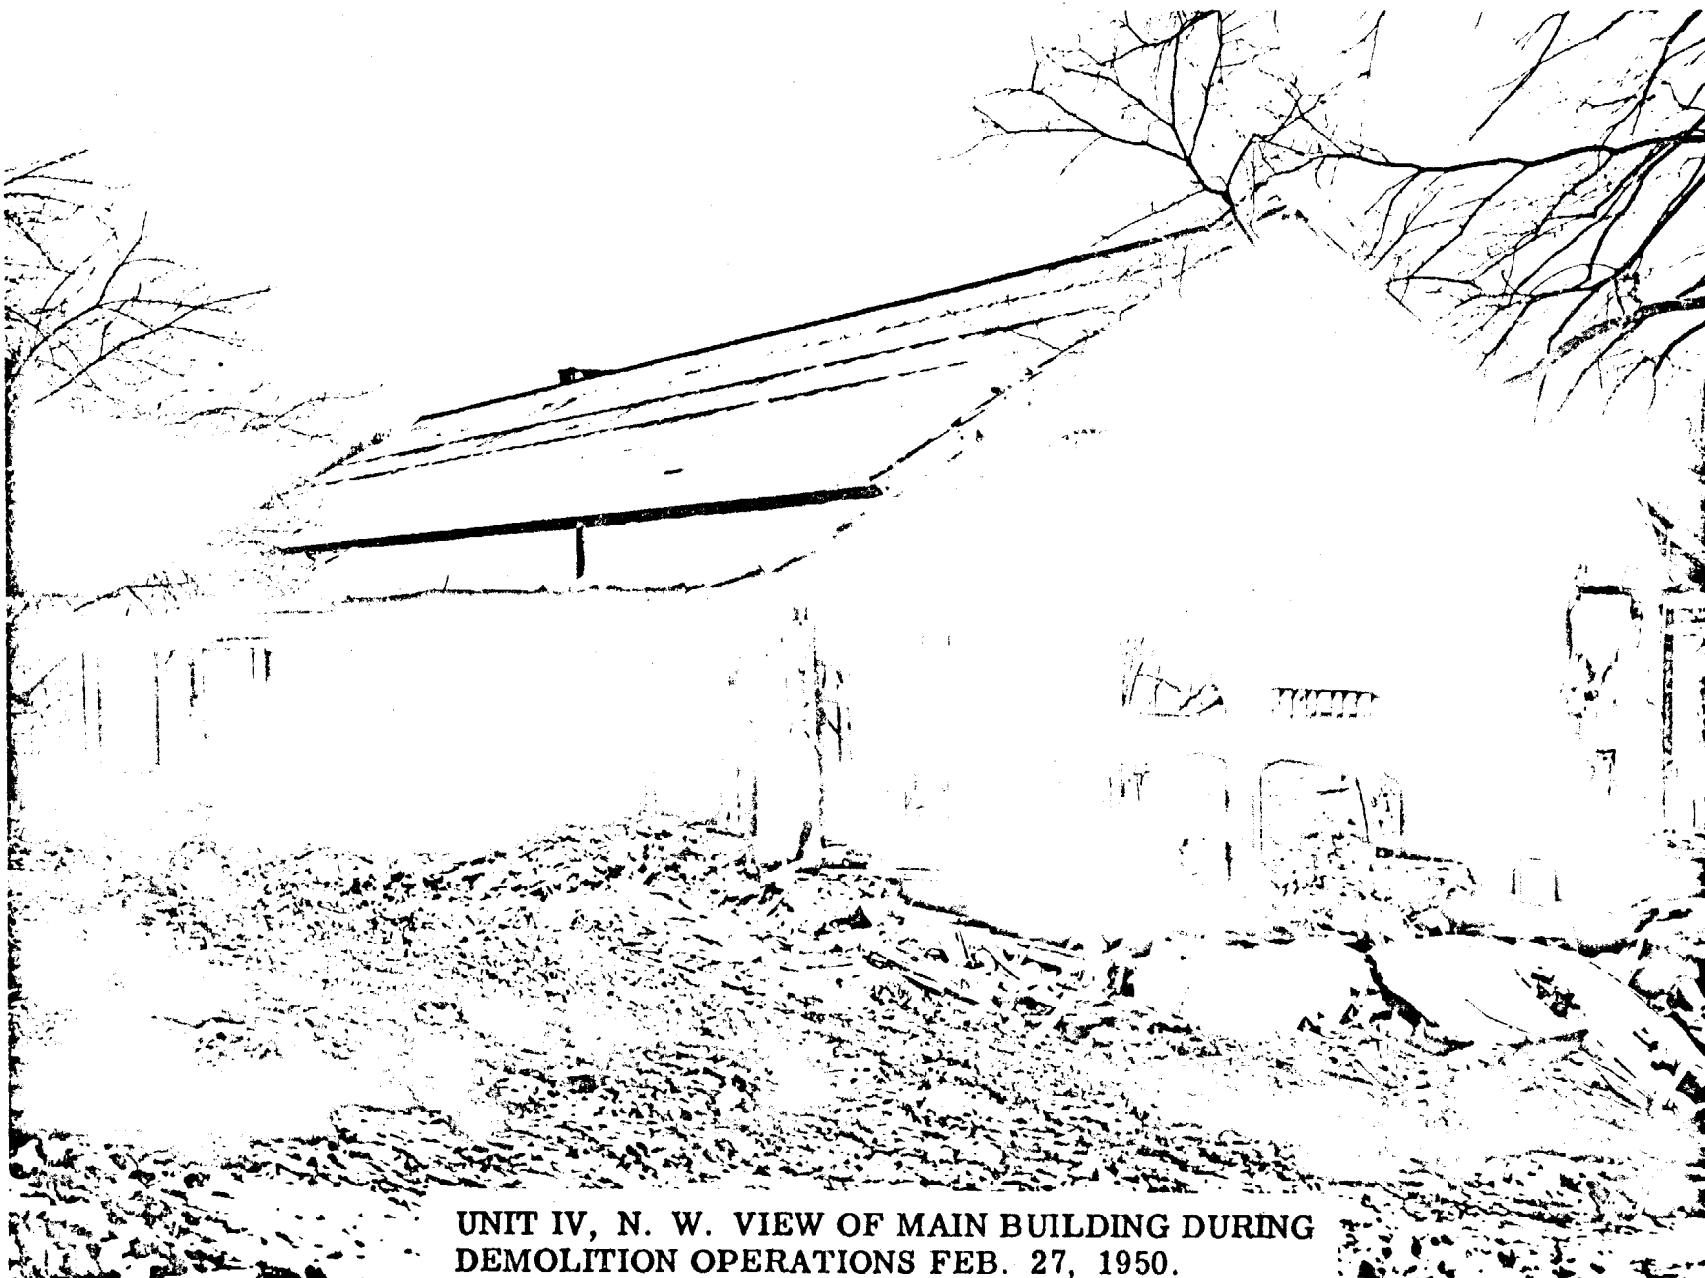
FIGURE 4

UNIT IV, N. W. VIEW OF MAIN BUILDING DURING
DEMOLITION OPERATIONS FEB. 27, 1950.

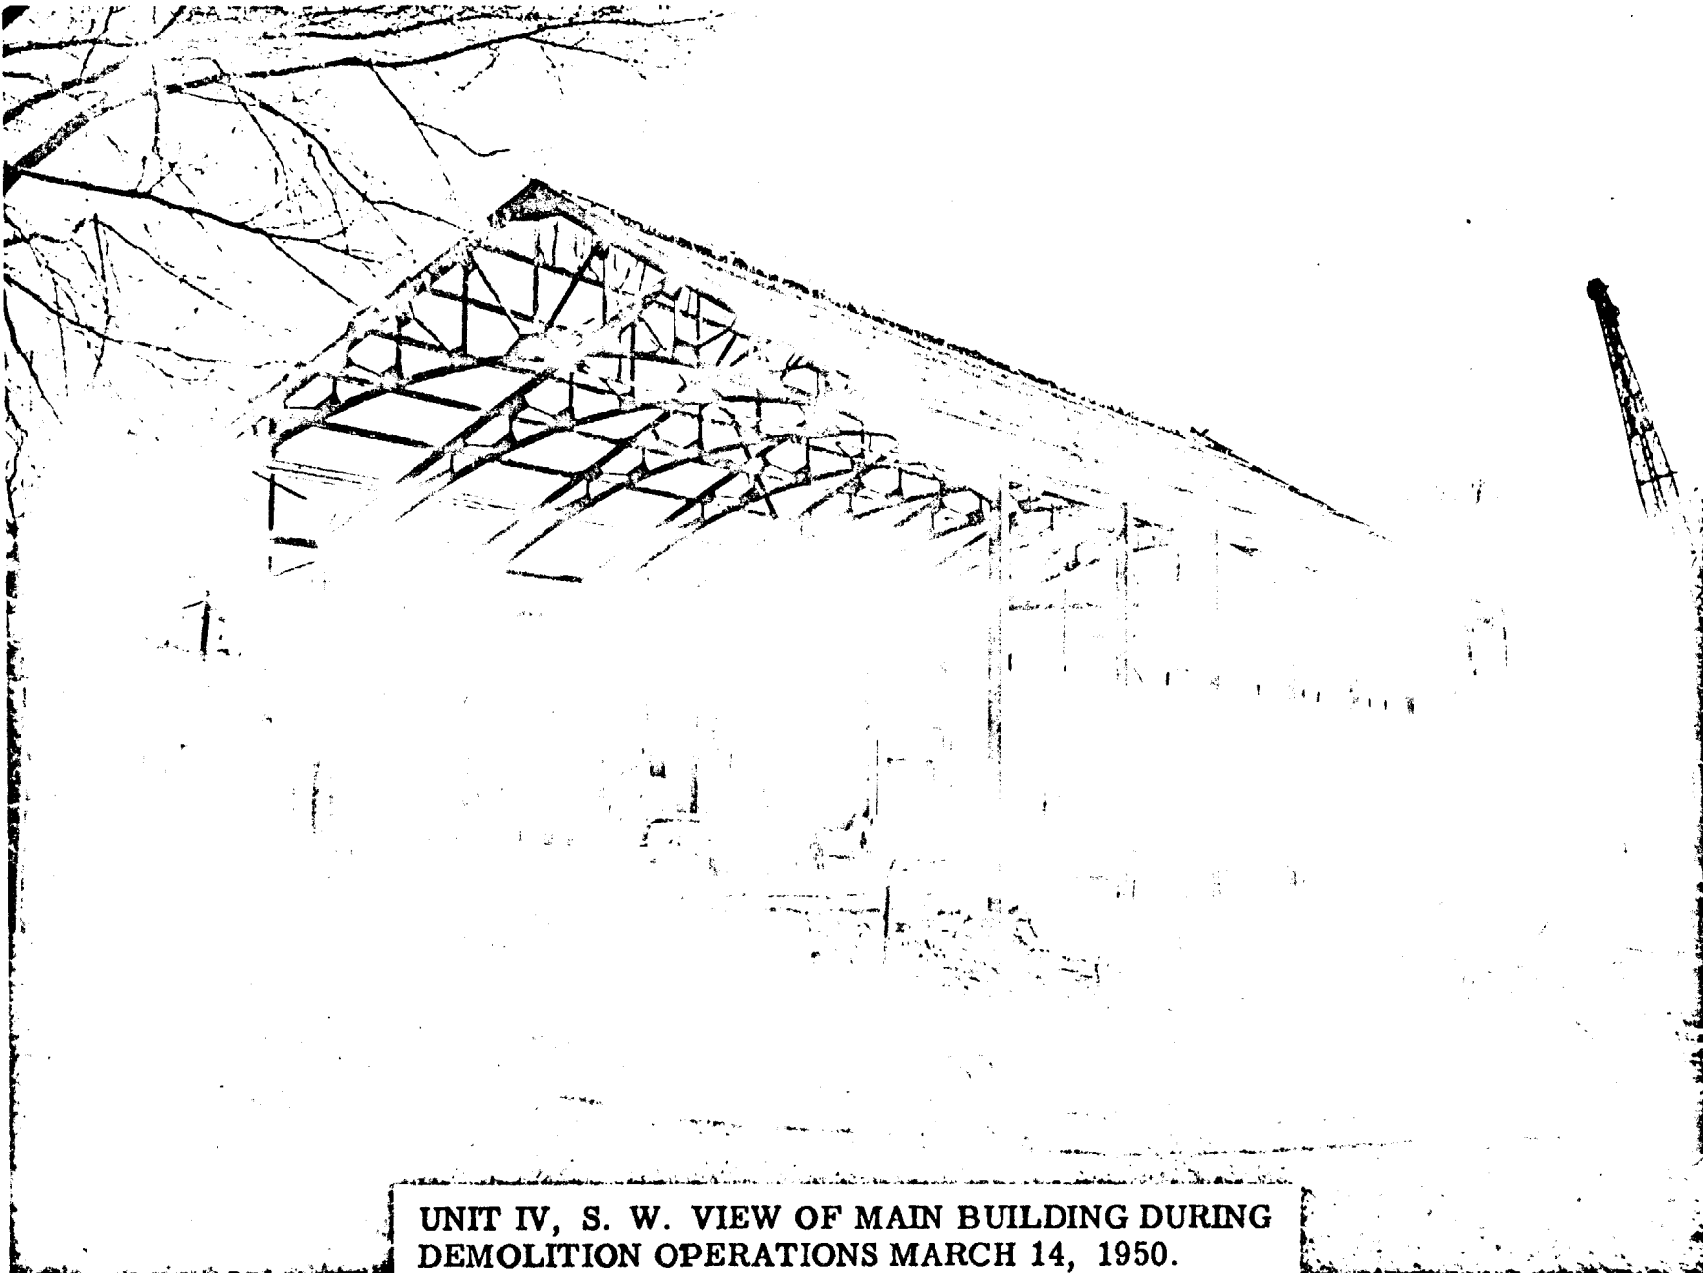
FIGURE 12

UNIT IV, S. W. VIEW OF MAIN BUILDING DURING
DEMOLITION OPERATIONS MARCH 14, 1950.
